**Preliminary Assessment
Mercury/Peeler's Dry Cleaner**

(MD-617)

February 12, 2013

Prepared by: Maryland Department of the Environment
Land Management Administration
1800 Washington Blvd.
Baltimore, MD 21230

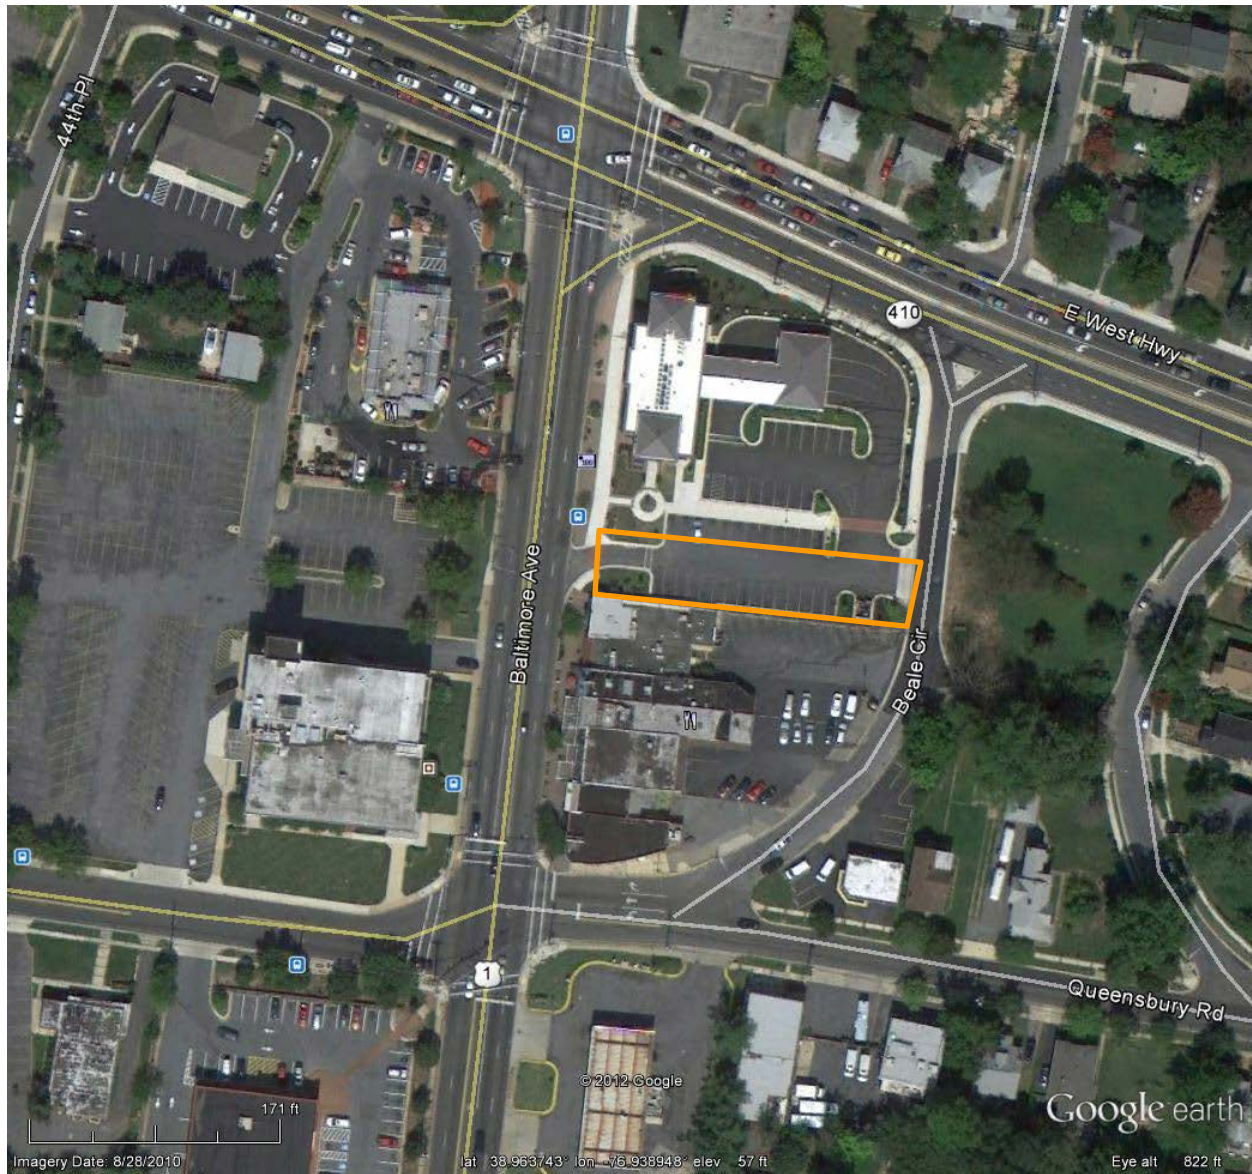
Figure 3: Aerial Photo of Mercury/Peeler's Dry Cleaner

Current View Showing the new parking area and bank structure.

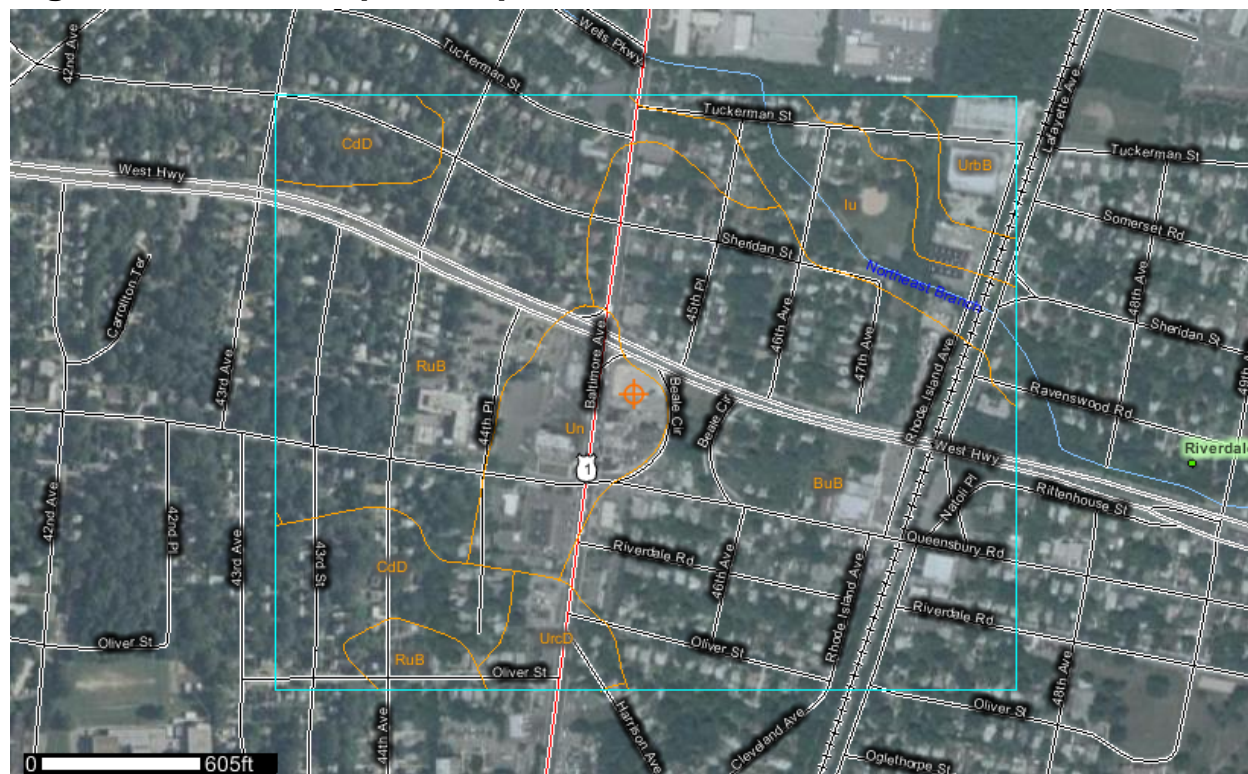
Figure 11: Soil Complex Map of Riverdale Area

Several soil Associations are found in the Riverdale area surrounding the site (Fig. 11). These include Beltsville-Urban land complex, Christiana-Downer-Urban land complex, Issue-Urban land complex, Russett-Christian-Urban land complex, Sassafras-Urban land and undefined Urban land. The land under the site is unclassified Urban Land. Urban land has a

high run-off potential and is classed hydrologically as such. The various complexes are a mix of urban land and the several associated naturally occurring soil groups in the area. The Mercury/Peeler's site has been an urban complex since Riverdale was first incorporated in 1879. Concrete and asphalt cover much of the exposed space. The area has been worked extensively by man.

BuB	Beltsville-Urban land complex, 0 to 5 percent slopes
CdD	Christiana-Downer-Urban land complex, 5 to 15 percent slopes
Iu	Issue-Urban land complex, occasionally flooded
RuB	Russett-Christiana-Urban land complex, 0 to 5 percent slopes
SnB	Sassafras-Urban land complex, 0 to 5 percent slopes
Un	Urban land
UrbB	Urban land-Beltsville complex, 0 to 5 percent slopes
UrcD	Urban land-Christiana-Downer complex, 5 to 15 percent slopes

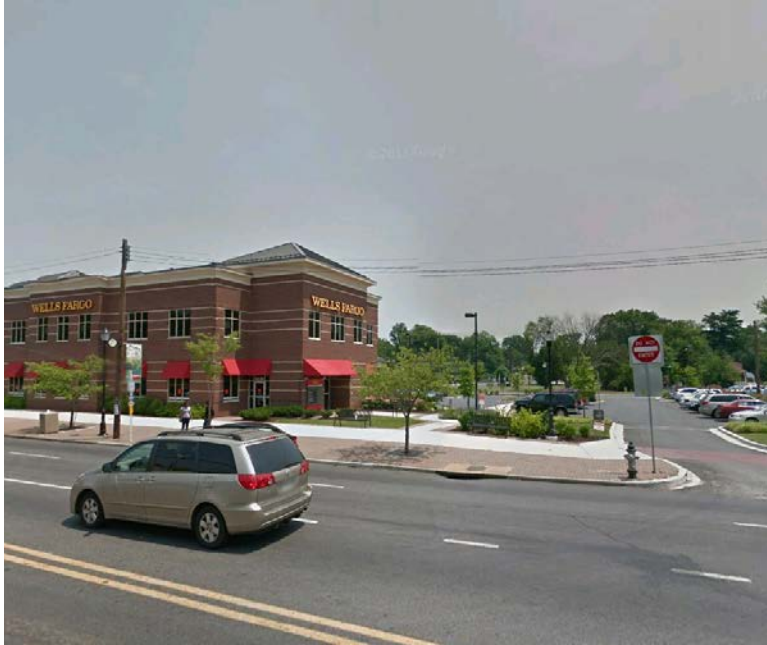
Lot From Rt. 1

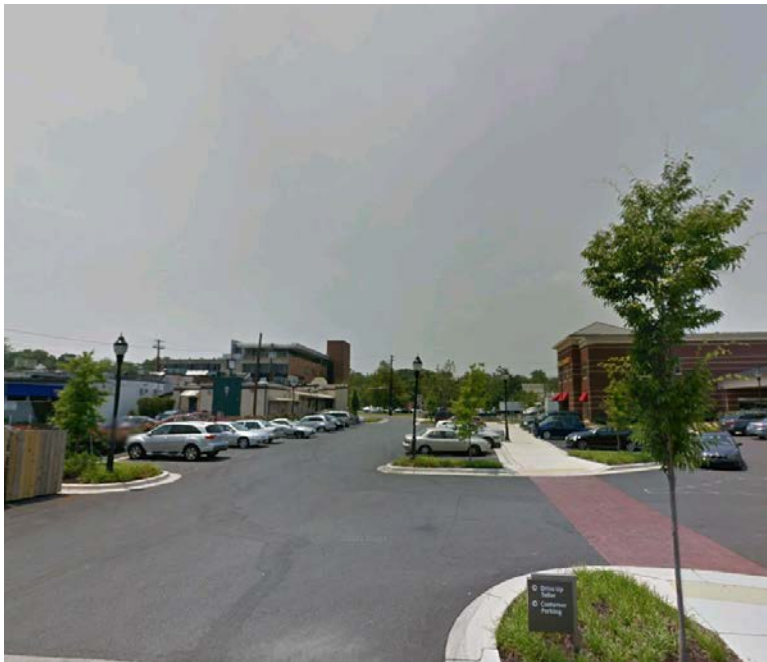
Lot From Circle
